CALCIUM PHOSPHATE COATINGS FOR MARBLE CONSERVATION: INFLUENCE OF ETHANOL AND ISOPROPANOL ADDITION TO THE PRECIPITATION MEDIUM ON THE COATING MICROSTRUCTURE AND PERFORMANCE

The effect of adding ethanol and isopropanol to aqueous solutions of diammonium hydrogen phosphate, used to create a passivating layer of calcium phosphates over marble, was investigated. Thanks to its weakening effect on the hydration sphere of ions in solution, ethanol allowed complete coverage of marble surface by a crack-free and pore-free layer of octacalcium phosphate. Even better results were obtained using isopropanol, because it has lower adsorption affinity to calcite than ethanol. Treatments involving alcohols provided good acid protection and also restored cohesion among calcite grains in weathered marble.

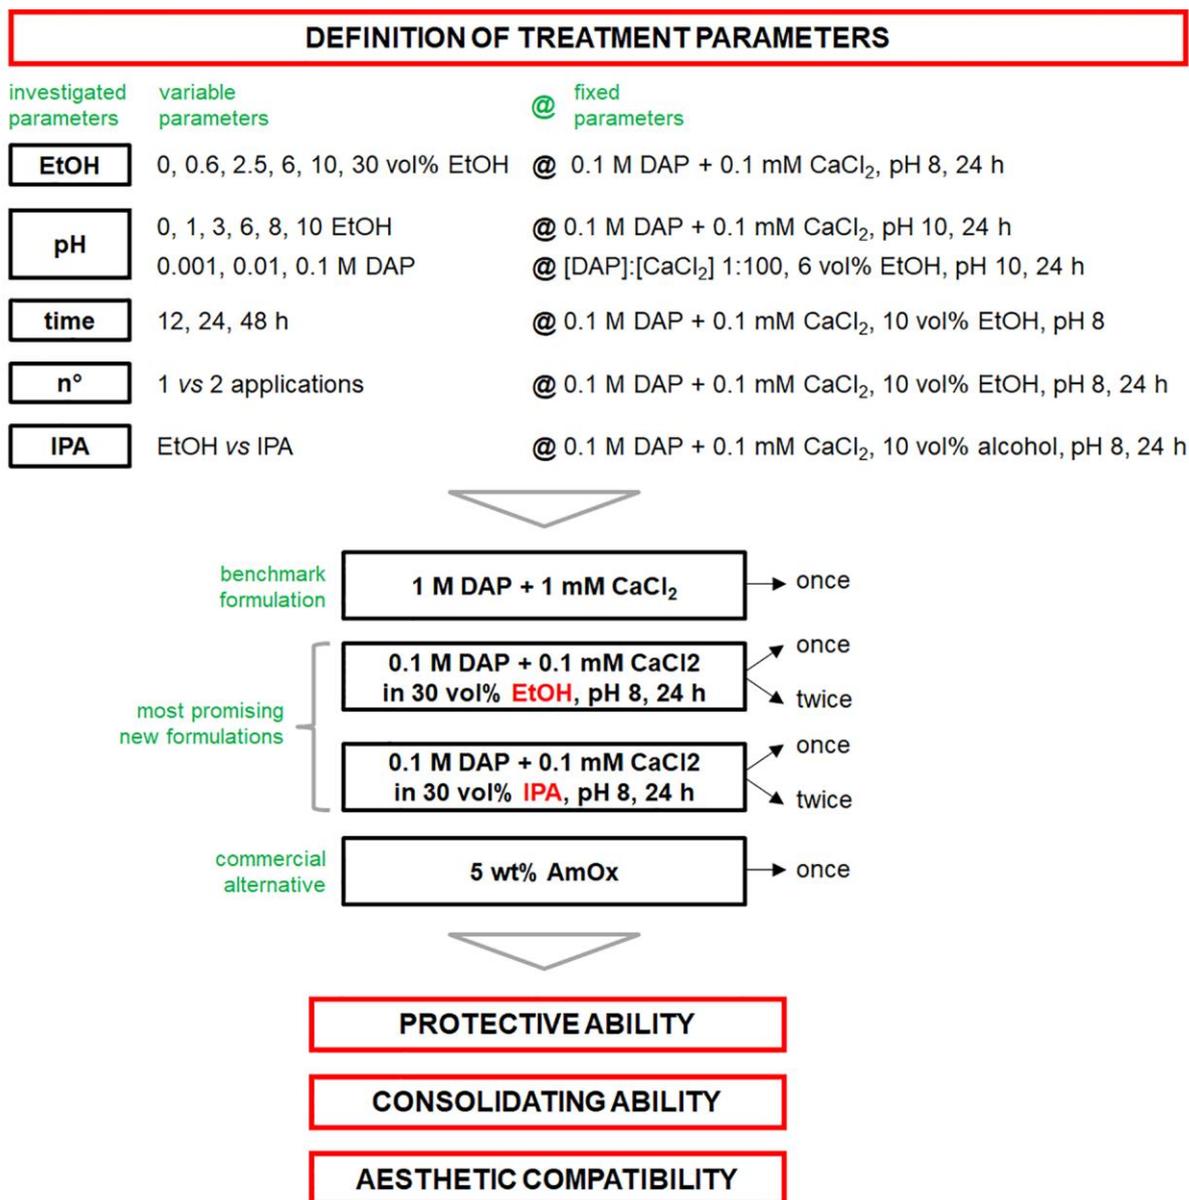
Figure 1. Scheme illustrating the investigated parameters and the whole rationale of the study.

The possible improvement of this formulation, in terms of surface coverage and microstructure, was investigated by exploring the influence of the parameters described in § 2.2.1 - § 2.2.5. A summary of the investigated parameters is reported in Figure 1. Treatment by a 5 wt% aqueous solution of ammonium oxalate (labelled as "AmOx") was also taken as a commercial benchmark. All treatments were performed by immersing a cubic specimen in a plastic container with 200 ml of solution and then rotating the containers to ensure stirring of the solutions during treatment. The treatment duration was 24 hours, unless otherwise specified. At the end of the treatment, the specimens were taken out of the solutions, rinsed with deionized water and then dried at room temperature. The features of the different coatings were determined as described in § 2.2.6.

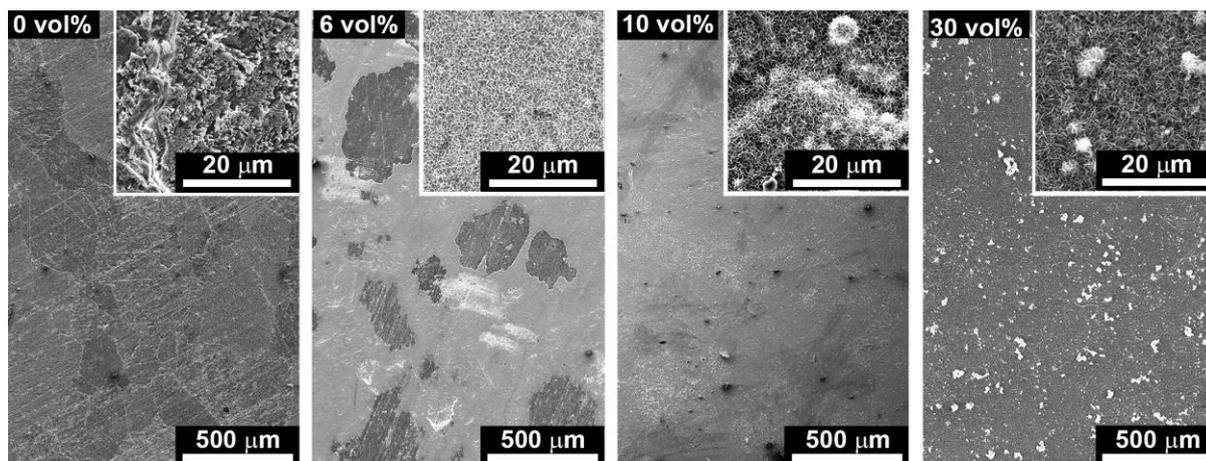
Figure 2. Coverage of marble surface by CaP coatings formed by reaction with a 0.1 M DAP and 0.1 mM CaCl₂ solution containing increasing amounts of ethanol.

When no ethanol is added to a 0.1 M DAP and 0.1 mM CaCl₂ solution, no CaP coating is formed over calcite (Figure 2). This is a consequence of the very low amount of PO₄³⁻ ions (needed to form HAP), originating from DAP dissociation at pH 8 (Table 3). When 0.6 or 2.5 vol% ethanol is added, some isolated new CaP phases are formed, but the coating is far from being continuous. When the ethanol amount is increased to 6 vol%, a more uniform coating is formed, however still exhibiting several bare areas (Figure 2). A continuous coating is achieved when the ethanol amount is further increased to 10 and 30 vol% (Figure 2). In the case of 30 vol% addition, some precipitation of CaP particles occurred already in the solution, leading to particle deposition over the coating. This makes the 10 vol% addition preferable, because it allows complete coverage of the marble surface with only a few particles deposited over the coating (Figure 2).

When the DAP concentration was reduced and ethanol was added to the solution, cracking was prevented and a much denser microstructure was achieved (Figure 2), which allowed a significant improvement in the protecting ability (“EtOH” sample in Figure 2). The time required for pH increase from 4.75 to 5.75 was more than doubled (from 3.9 h to 8.3 h, Table 2), and the “EtOH” curve remained below the untreated reference “UT” for the whole duration of the test (Figure 9). When observed after the acid attack test (Figure 10), the coating exhibited no diffused detachment (unlike the “1 M DAP” sample), but still some cracking, which allowed the acid to reach the substrate and cause the increase in pH registered after some time.

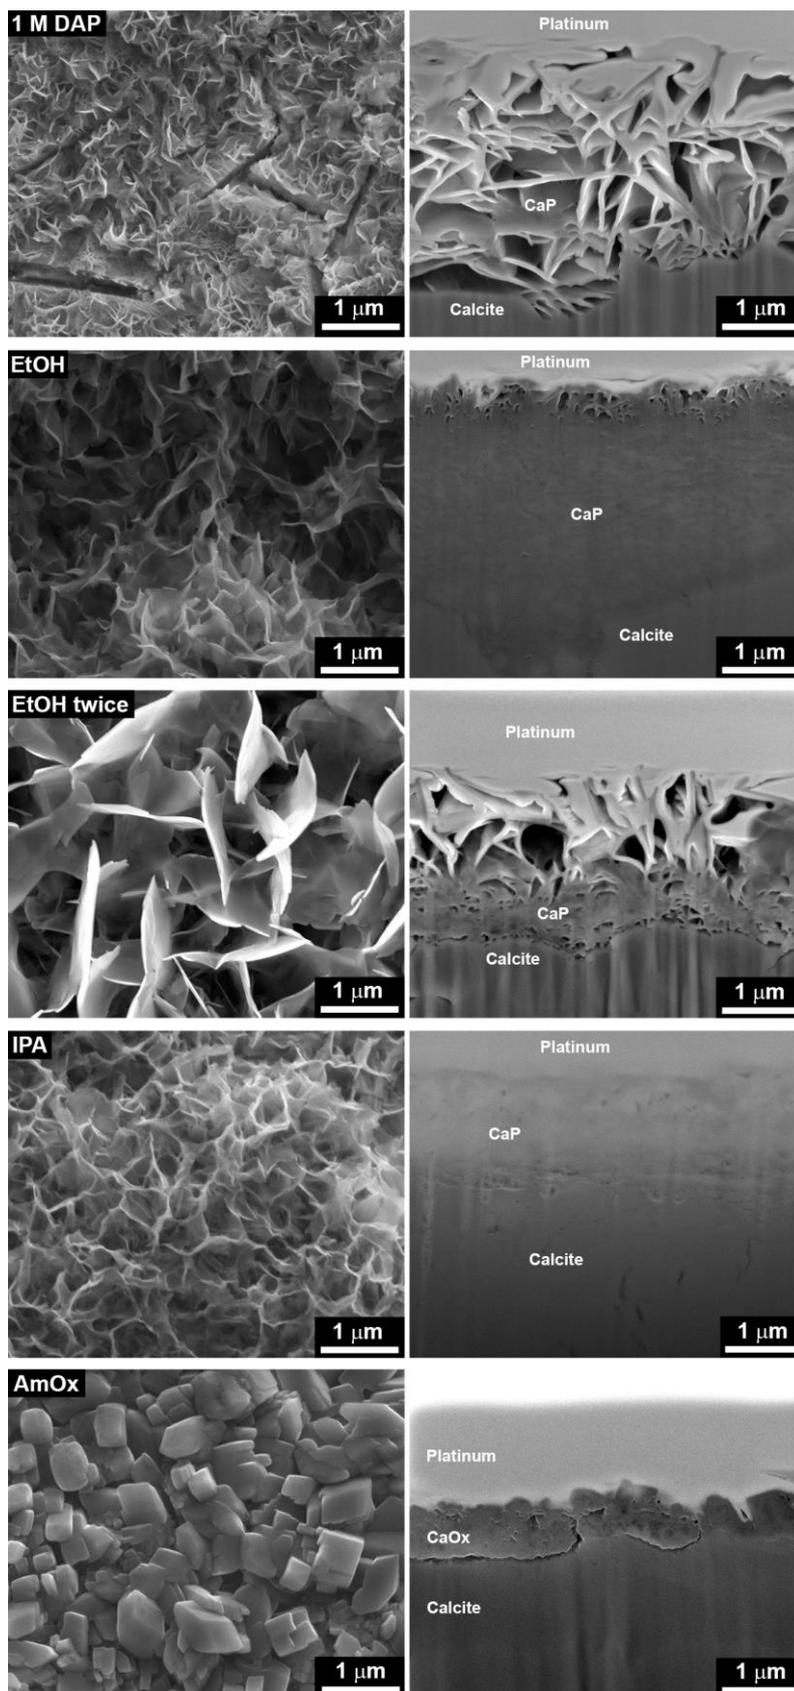
Figure 3. Surface morphology (left) and cross section (right) of marble samples subjected to different treatments.

In addition to the increased surface coverage, ethanol addition also had a significant effect on the coating microstructure and tendency to crack. If one compares a specimen treated with a solution containing 0.1 M DAP, 0.1 mM CaCl₂ and 10 vol% ethanol (“EtOH” sample) with a specimen treated with a 1 M DAP and 1 mM CaCl₂ solution (“1 M DAP”), the following observations can be made. In both cases complete coverage of the marble surface is achieved. However, the “1 M DAP” specimen is affected by some cracking, likely developed during drying, while the “EtOH” specimen exhibits no visible cracks (Figure 3). In terms of porosity of the coating, FIB-SEM revealed that numerous large pores are present in the “1 M DAP” specimen (Figure 3), which are expected to negatively affect the acid resistance (cf. § 3.1.6). On the contrary, the “EtOH” specimen exhibits a much denser microstructure and no visible pores (Figure 3), apart from the top of the coating (right after the platinum layer), where the typical flower-like morphology of CaP is present. Notably, at the interface between the calcite substrate and the CaP coating (about 2-4 μm thick), good adhesion seems present (Figure 4).

Because repeated treatments had been found to significantly improve the surface coverage of marble particles by CaP coatings [22], the effect of repeating the “EtOH” treatment twice was investigated. As reported in Figure 3, this led to formation of huge CaP flakes on top of the coating, visible both from observation of the treated surface and in the FIB cross section (Figure 3). Even if the underlying layer exhibits a much denser microstructure than the superficial flakes, the adhesion at the coating-substrate interface seems worse compared to the single application, likely because the second treatment caused excessive growth and partial detachment of the coating from the substrate.

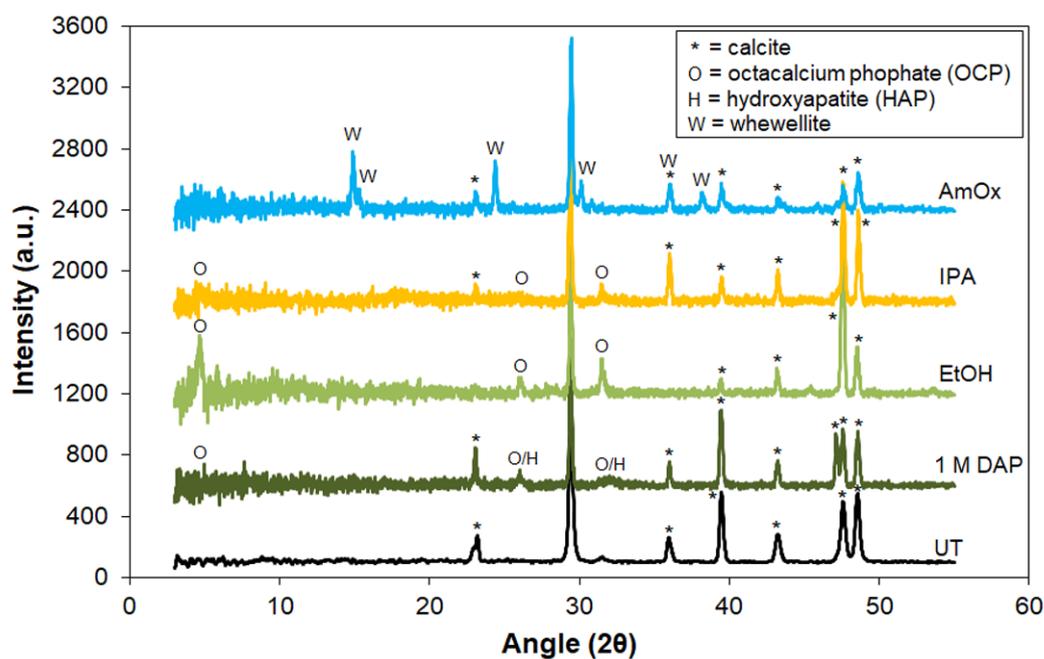
Figure 5. Mineralogical composition of untreated and treated specimens.

The addition of ethanol to the DAP solution also influenced the mineralogical composition of the coating (Figure 5). Whereas both HAP and octacalcium phosphate (OCP, Ca₈(PO₄)₆H₂·5H₂O) are present in the “1 M DAP” specimen (consistently with previous observations [3]), only OCP forms when ethanol is added to the DAP solution (“EtOH” specimen). This is in agreement with the previously reported decrease in Ca/P ratio of the final calcium phosphate when ethanol is added to DAP solution [32]. In spite of being slightly more soluble than HAP (the solubility at 25 °C being ~0.0081 g/l for OCP and ~0.0003 g/l for HAP [29]), OCP is still less soluble than calcite (~0.014 g/l [29]). Therefore, formation of a non-porous and non-cracked layer of OCP over marble is expected to provide significant acid protection, superior to a cracked and porous layer of less soluble HAP.

Consistently with the theoretical expectations, the amount of PO₄³⁻ ions in solution when 10 vol% IPA was added was found to be much higher than when the same amount of ethanol was added (0.71 mg/l vs 0.32 mg/l, respectively), basically corresponding to a 30 vol% ethanol addition (0.76 mg/l) (Table 3). Accordingly, the microstructure of the CaP coating formed with IPA addition was even denser than in the case of ethanol, the interface between the calcite substrate and the coating being hardly distinguishable (Figure 3). In terms of composition, the coating consisted of OCP, as in the case of ethanol addition (Figure 5).

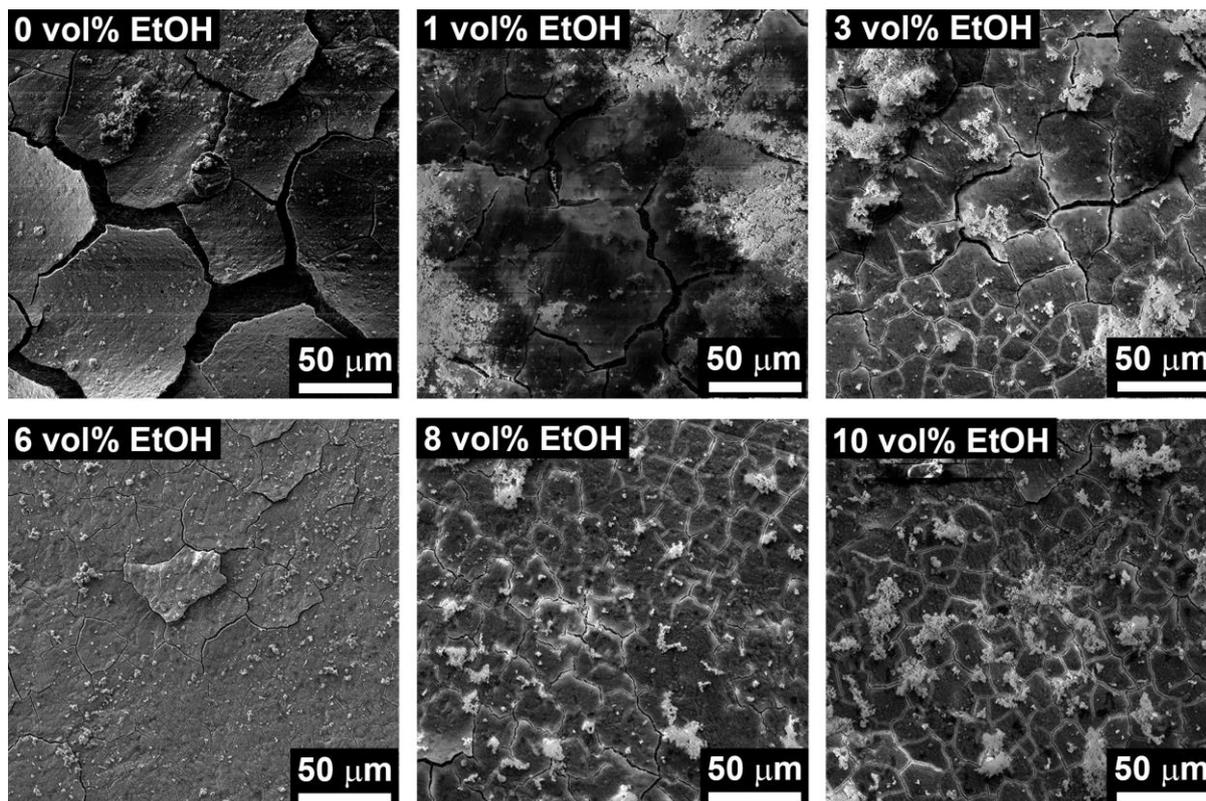
Figure 6. Morphology of CaP coatings formed at pH 10 for increasing amount of ethanol addition to the DAP solution.

Increasing the pH of the DAP solution to 10 using NH_4OH had a huge effect on the CaP coating development, as illustrated in Figure 6. Even with no ethanol addition, at pH 10 abundant formation of new phases occurred when marble was treated with a 0.1 M DAP and 0.1 mM CaCl_2 solution, while no formation took place at pH 8 (Figure 2). This is a consequence of the higher amount of PO_4^{3-} ions originating from DAP dissociation at high pH [19]. However, because of excessive growth, the CaP coating is extensively cracked (Figure 6), which prevents effective acid protection. To try to avoid cracking, two routes were tested. First, increasing ethanol additions to the DAP solution were tested, to develop a more adherent coating with more refined

microstructure. As illustrated in Figure 6, a reduction in cracking and flake detachment was achieved, but cracks were not completely eliminated. Moreover, the combination of high pH and high ethanol additions led to an excessive PO_4^{3-} amount, which resulted in abundant precipitation of CaP particles over the coating (Figure 6). Therefore, considering that at higher pH a lower concentration of DAP could be enough to achieve complete surface coverage, a progressive reduction in DAP concentration from 0.1 M to 0.01 M and 0.001 M was tested (the CaCl_2 :DAP concentration always being 1:1000). As illustrated in Figure 7, a DAP concentration of 0.01 M at pH 10 was enough to obtain complete coating of the surface. However, the coating exhibited some cracking (Figure 7). A further reduction of the DAP concentration by 10 times led to no coating formation (Figure 7), because the PO_4^{3-} content became too low. Since the boosting effect of high pH was always linked to cracking in the tested conditions, only treatments at pH 8 were considered for the prosecution of the study.

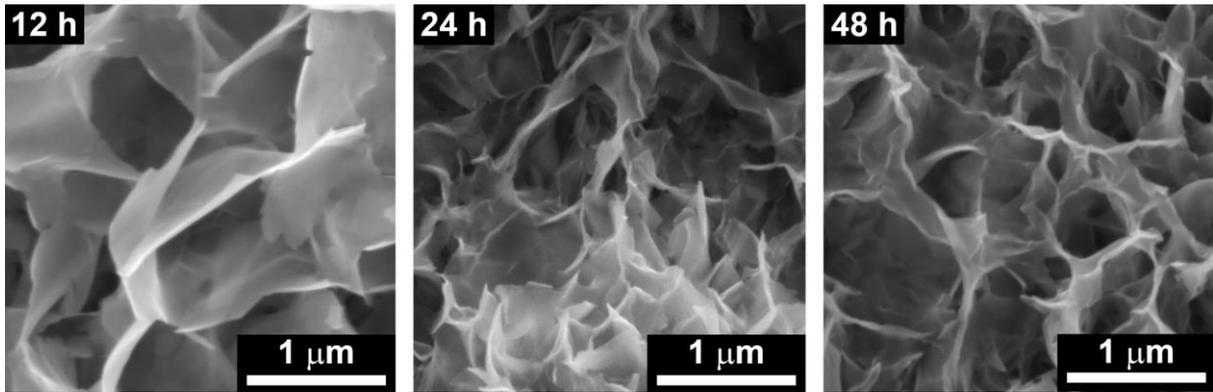
Figure 8. Morphology of CaP coatings formed after treatment for increasing time.

Considering that ethanol addition significantly favours formation of the new CaP coating, the effect of reducing the treatment duration from 24 to 12 hours was investigated. At the same time, because an evolution of the phase composition and microstructure has been reported in the literature passing from 24 to 48 hours (however in different conditions, especially without stirring of the DAP solution [43]), a longer reaction time was also considered. However, in the case of a solution containing 0.1 M DAP, 0.1 M CaCl_2 and 10 vol% ethanol, no remarkable difference in the coating morphology was noticeable for the different reaction times investigated (Figure 8), hence treatment for 24 hours (as recommended in [3]) was adopted for further comparisons.

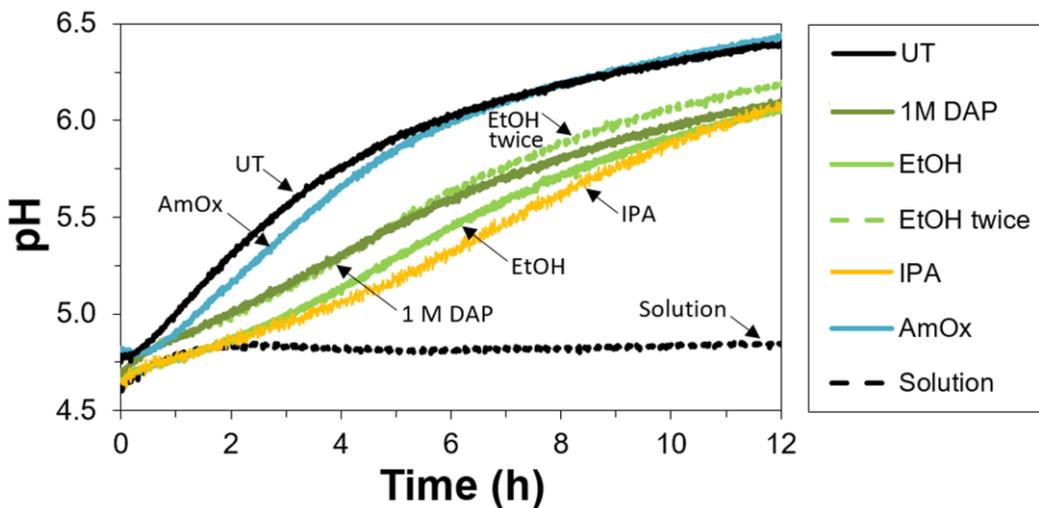
Figure 9. Acid resistance (in terms of pH increase over time) of untreated and treated specimens (the curves are averages for two specimens, one tested on the rougher surface and one tested on the smoother surface). The curve of the acid solution alone (with no sample) is illustrated as well.

For the most promising formulations of the phosphate treatments (namely, “EtOH”, “EtOH twice”, “IPA” and the reference “1 M DAP”, Table 2), as well as the reference conditions “UT” and “AmOx”, the results of the acid attack test are illustrated in Figure 9. Results are expressed in terms of pH increase over time of the acid solution simulating rain, in which the samples had been immersed. The appearance of the coating before and after the acid attack test is illustrated in Figure 10.

First, the stability of the solution pH when no sample was immersed was checked and no pH increase was in fact recorded. The “UT” sample caused a quick increase of pH during the test (Figure 9). This increase is due to H⁺ ions in the solution being consumed as Ca²⁺ ions are released from calcite [1]. Since the Ca²⁺ concentration increases as the test proceeds, the rate of dissolution decreases, because the dissolved Ca²⁺ ions remain in the solution [1]. At the end of the test, the marble surface is significantly etched, so that single grains and grains boundaries become apparent (Figure 10).

The “1 M DAP” treatment was able to provide some protection against dissolution, as denoted by the fact that the respective curve lies well below the untreated reference (Figure 9). For instance, if one compares the time required for the solution pH to increase by 1 unit (from 4.75 to 5.75), the “1 M DAP” treatment allowed an increase from 3.9 h (“UT”) to 7.3 h (“1 M DAP”) (Table 2). However, at the end of the acid attack test, the coating exhibited several areas where it had been detached and removed (Figure 9). This is a consequence of the presence of cracks and pores

When repeated twice, the EtOH treatment performed a little worse, the curve basically overlapping with that of the “1 M DAP” sample (Figure 9) and the time for pH shift decreasing to 6.8 h (Table 2). Accordingly, diffused cracking was noticed when the sample was analysed after the acid attack test (Figure 10). The worsening of the treatment performance when repeated twice is in agreement with the less dense microstructure observed in the “EtOH twice” specimen (Figure 2), likely related to the excessive growth of the film during the second application.

The acid resistance of the “IPA” sample resulted improved with respect to the “EtOH” sample, especially at the beginning of the test (Figure 9), the time required for pH increase to 5.75 being the longest (8.7 h against 8.3 h for the “EtOH” sample and 3.9 h for the “UT” reference, Table 2). The ESEM observation of the coating after the acid attack test revealed that no diffuse detachment occurred, even if cracks are visible (similarly to the case of the “EtOH” sample) (Figure 10).

It is important to point out that, even if initially they exhibited sensibly different behaviours, the curves of the different phosphate treatments converge as the test proceeds, so that after 12 h only minor differences are present (Figure 9). This is a consequence of the fact that, even if the coating exhibits complete coverage and no cracks, still some sporadic defects can be noticed. As illustrated in Figure 11, when impurities are present over the marble surface, the formation of the coating is interrupted. The remaining bare areas are weak points, from where the attack on the marble surface can start and propagate to the adjacent areas, where the coverage was originally good. Moreover, it was observed that the continuity of the coating is sometimes abruptly interrupted at the boundary between two grains, so that one calcite grain has perfect coverage and the adjacent one remains almost bare (Figure 11). This is thought to be a consequence of the different orientation of calcite grains, which might be more or less favourable for the development of the CaP coating. In fact, epitaxial growth of HAP over calcite has been reported in the literature, but only along privileged crystallographic directions of the calcite and HAP crystals [48]. Along these directions, the distance between the phosphate groups in the HAP crystal closely matches the distance between carbonate groups in the calcite crystal, so that epitaxial growth can occur [48]. However, in marble where calcite grains have random orientation, this is generally not the case. Epitaxial growth might occur over those grains that have a particularly favourable orientation (over these grains, HAP nucleation is also favoured by the reduction in supersaturation needed for nucleation [48]) and from these grains the coating can spread to the adjacent ones with different orientation. However, when the coating development reaches grains with a particularly unfavourable orientation, formation over these grains may be impeded. Possible routes to overcome the influence of the underlying calcite crystals orientation on the development of the phosphate coating are currently being investigated.

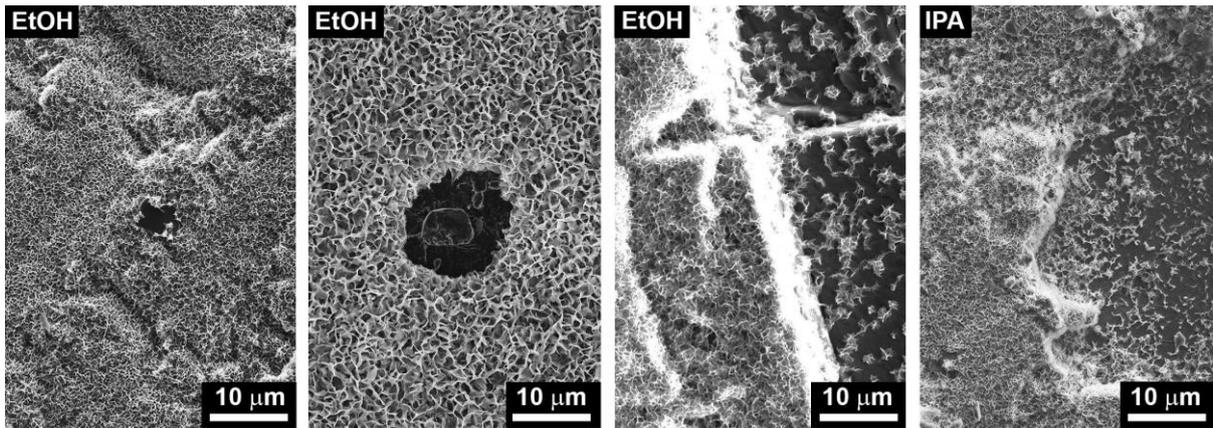
Figure 11. Interruptions in the CaP coating due to the presence of impurities (left two images) and due to the different crystallographic orientation of calcite grains (right two images).

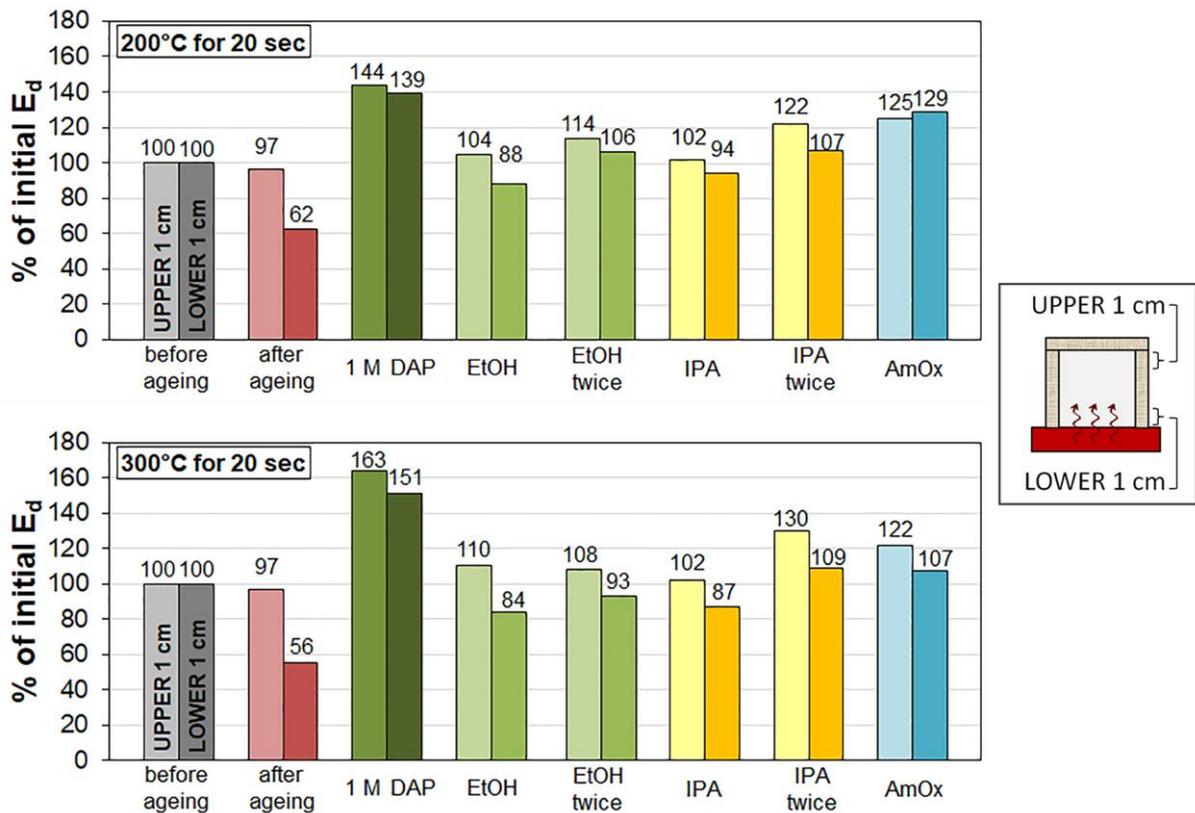
Figure 12. Variations in dynamic elastic modulus (E_d), with respect to the initial value, after accelerated ageing and after consolidation by different treatments. Values refer to the lower and upper 1 cm of the specimens, which had been subjected to accelerated ageing as illustrated in the inset: one face of the specimens was put in contact with the hot plate (in red), while the sides and the top were wrapped with a high temperature resistant insulator (in grey), to ensure the uni-directional heat flux.

After accelerated ageing by contact with a hot plate for 20 seconds, in the first 1 cm from the heated surface the specimens exhibited a 38% E_d decrease after heating at 200 °C and a 44% E_d decrease after heating at 300 °C (Figure 12). These values are in very good agreement with those predicted by the mathematical model (35% and 42%, respectively) [28], which was used to calculate the heating temperature and time required to produce damage similar to that experienced in the field by naturally weathered marble [27-29]. At the same time, the upper 1 cm of the sample underwent no substantial E_d decrease (Figure 12), as expected.

Consolidation by the “1 M DAP” treatment proved to be the most effective among all the investigated treatments, being able to increase E_d in the weathered part up to 139% (samples heated at 200 °C) and 151% (samples heated at 300 °C) of the initial value. The higher consolidating efficacy in samples with higher initial damage is consistent with previous results obtained on limestone [21]. The fact that the “1 M DAP” treatment was able to increase mechanical properties the most, in spite of the presence of cracks and pores in the formed CaP layer, derives from the following fact. Whereas in the case of *protection* it is essential that the formed coating continuously cover the surface and be crack- and pore-free, in order to prevent acid from reaching the substrate, this is not as important in the case of *consolidation*. In this latter case, the main requirement is that the newly formed material be able to seal the tip of the cracks among grains [50]. If the crack tip is effectively sealed, then the continuity of the coating and the presence of cracks and pores are not as detrimental as in the case of acid protection (however, cracks in the coating might propagate to the crack between grains, so uncracked coatings are nevertheless preferable). A potentially negative aspect of the high consolidating effectiveness of the “1 M DAP” treatment is that not only the initially deteriorated part (lower 1 cm), but also the initially sound part (upper 1 cm) underwent a significant mechanical improvement (Figure 12). This is undesired, because over-strengthening of the sound part might lead to mechanical incompatibility between the treated part and the substrate, potentially leading to its detachment [51,52]. Therefore, treatments able to restore mechanical properties of the weathered part, without causing excessive strengthening of the sound part are recommended [51,53].

Specimens consolidated by “AmOx” exhibited remarkable mechanical improvement, second only to the “1 M DAP” specimens (Figure 12). In fact, the initial modulus in the weathered part was completely restored and even enhanced after a single application (E_d up to 129% and 107% in specimens heated at 200 and 300 °C, respectively), with considerable strengthening also of the sound part (E_d up to 122–125%). Such mechanical improvement is notable, considering that in a previous study we found the consolidating ability of the ammonium oxalate treatment to be very modest [29]. The poor consolidating behaviour of ammonium oxalate was ascribed to the reduced depth of formation of whewellite [29], owing to the very rapid reaction between the ammonium oxalate solution and calcite [54]. In addition to the different thickness of samples to be consolidated (1 cm in the present case, 2 cm in the previous case [29]), a possible explanation for the better results obtained in this study may be the different application technique. While in the previous study the ammonium oxalate solution had been applied by brushing [29], in the present study it was applied by vacuum impregnation, which likely allowed to achieve a deeper and quicker penetration of the consolidating solution into marble microcracks, leading to higher strengthening. However, it should be noted that, given the low resistance of the newly formed whewellite to dissolution in acid, it is not unlikely that most of the mechanical improvement induced by the “AmOx” treatment could be lost after prolonged exposure to rain.

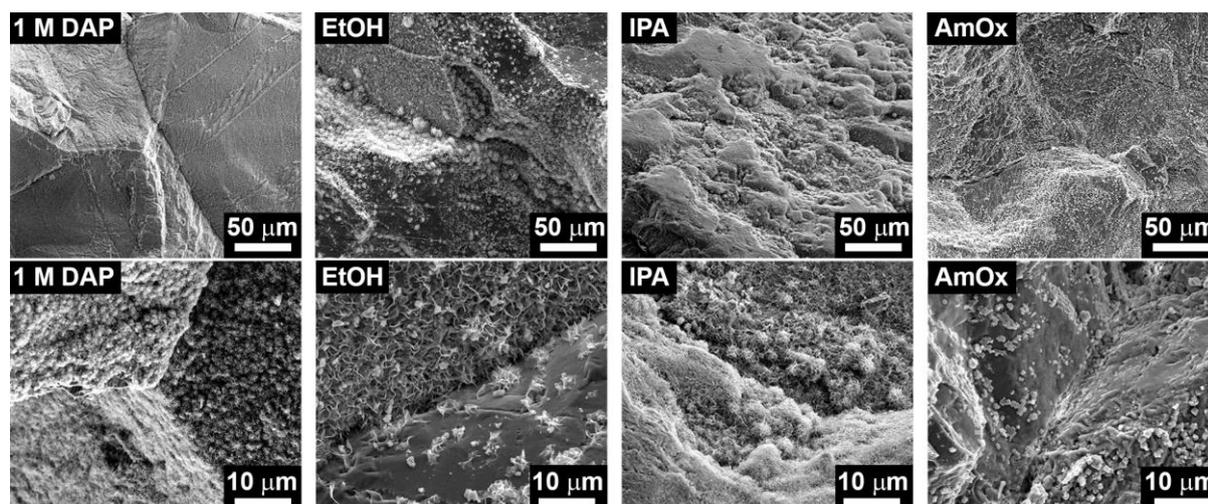
Figure 13. New phases formed inside microcracks between calcite grains after consolidation by different treatments.

After the E_d measurement, the formation of new phases in the microcracks among calcite grains was assessed by ESEM observation of fracture samples obtained by chisel from the tested specimens.
